Inspection Report

Sample Report

0000 Road
Boro, NC 00000

Inspection Date: 1/16/2007 Inspector: Bill McKnight Report No.: 2728

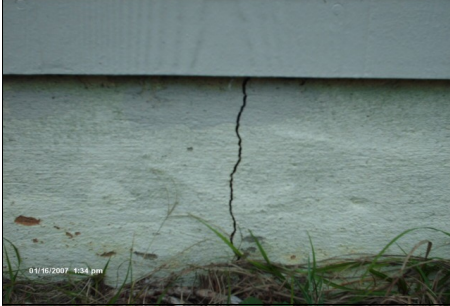
Location**East side****Comment**

Location: East side Defect: Crack in slab

Implication: Settlement crack

Crack in slab, East side, Settlement crack, not a problem now, keep an eye on it to make sure it does not increase in width.

Recommendation: Subsequent Observation by a Qualified Specialist

Comments: This settlement crack not a problem now. Keep an eye on it to make sure it does not increase in width. If it does, call me.

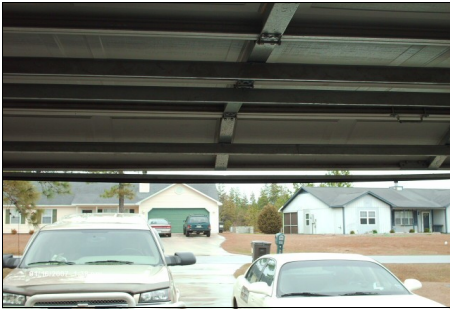
Garage**Comment**

Location: Garage Defect: Overhead door latch needs adjustment, loose bottom seal

Implication: Hard to latch door, weather leaks inder seal

Overhead door latch needs adjustment, loose bottom seal, Garage, Hard to latch door, weather leaks under seal, Repair by a Licensed General Contractor

Recommendation: Repair by a Licensed General Contractor

Comments: I think the door can be repaired and adjusted by an overhead door company with little problem.

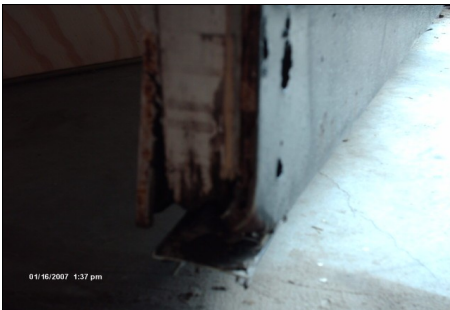
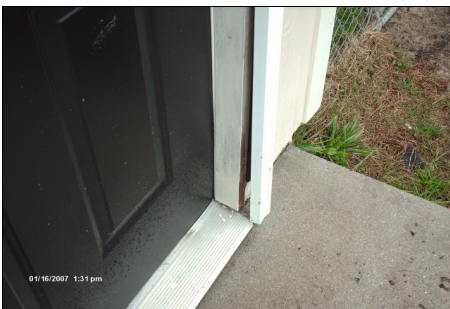
Rear garage door**Comment**

Location: Garage, rear door Defect: Rot and rust on door bottom, trim out of place

Implication: May let water in

Rot and rust on door bottom, trim out of place, Garage, rear door, May let water in, Repair by a Licensed General Contractor, Cut off the bottom of the trim, attach it to the jam, caulk the bottom of the door.

Recommendation: Repair by a Licensed General Contractor

Comments: Cut off the bottom of the trim, attach it to the jam, caulk the bottom of the door.

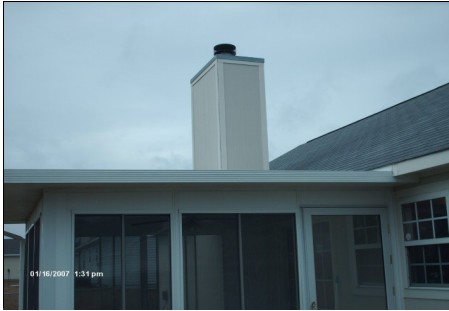
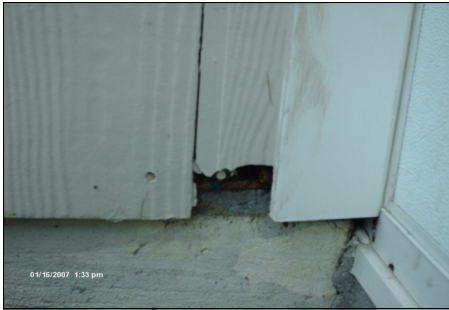
Location: Rear and chimney chase Defect: Caulk separation and hole

Implication: Allows water to penetrate unintended areas

Caulk separation and hole, Rear and chimney chase, Allows water to penetrate unintended areas, a little caulk will do the job.

Recommendation: Repair by a Licensed General Contractor

Comments: A little caulk will do the job on both.
